Research Note 84-142

HUMAN FACTORS AND SAFETY EVALUATION OF THE  
SPECIAL COMMUNICATIONS SYSTEM AN/GSC-40  
COMBINED GROUND COMMAND POST TERMINAL

Richard A. Kass and Edwin R. Smootz

December 1984

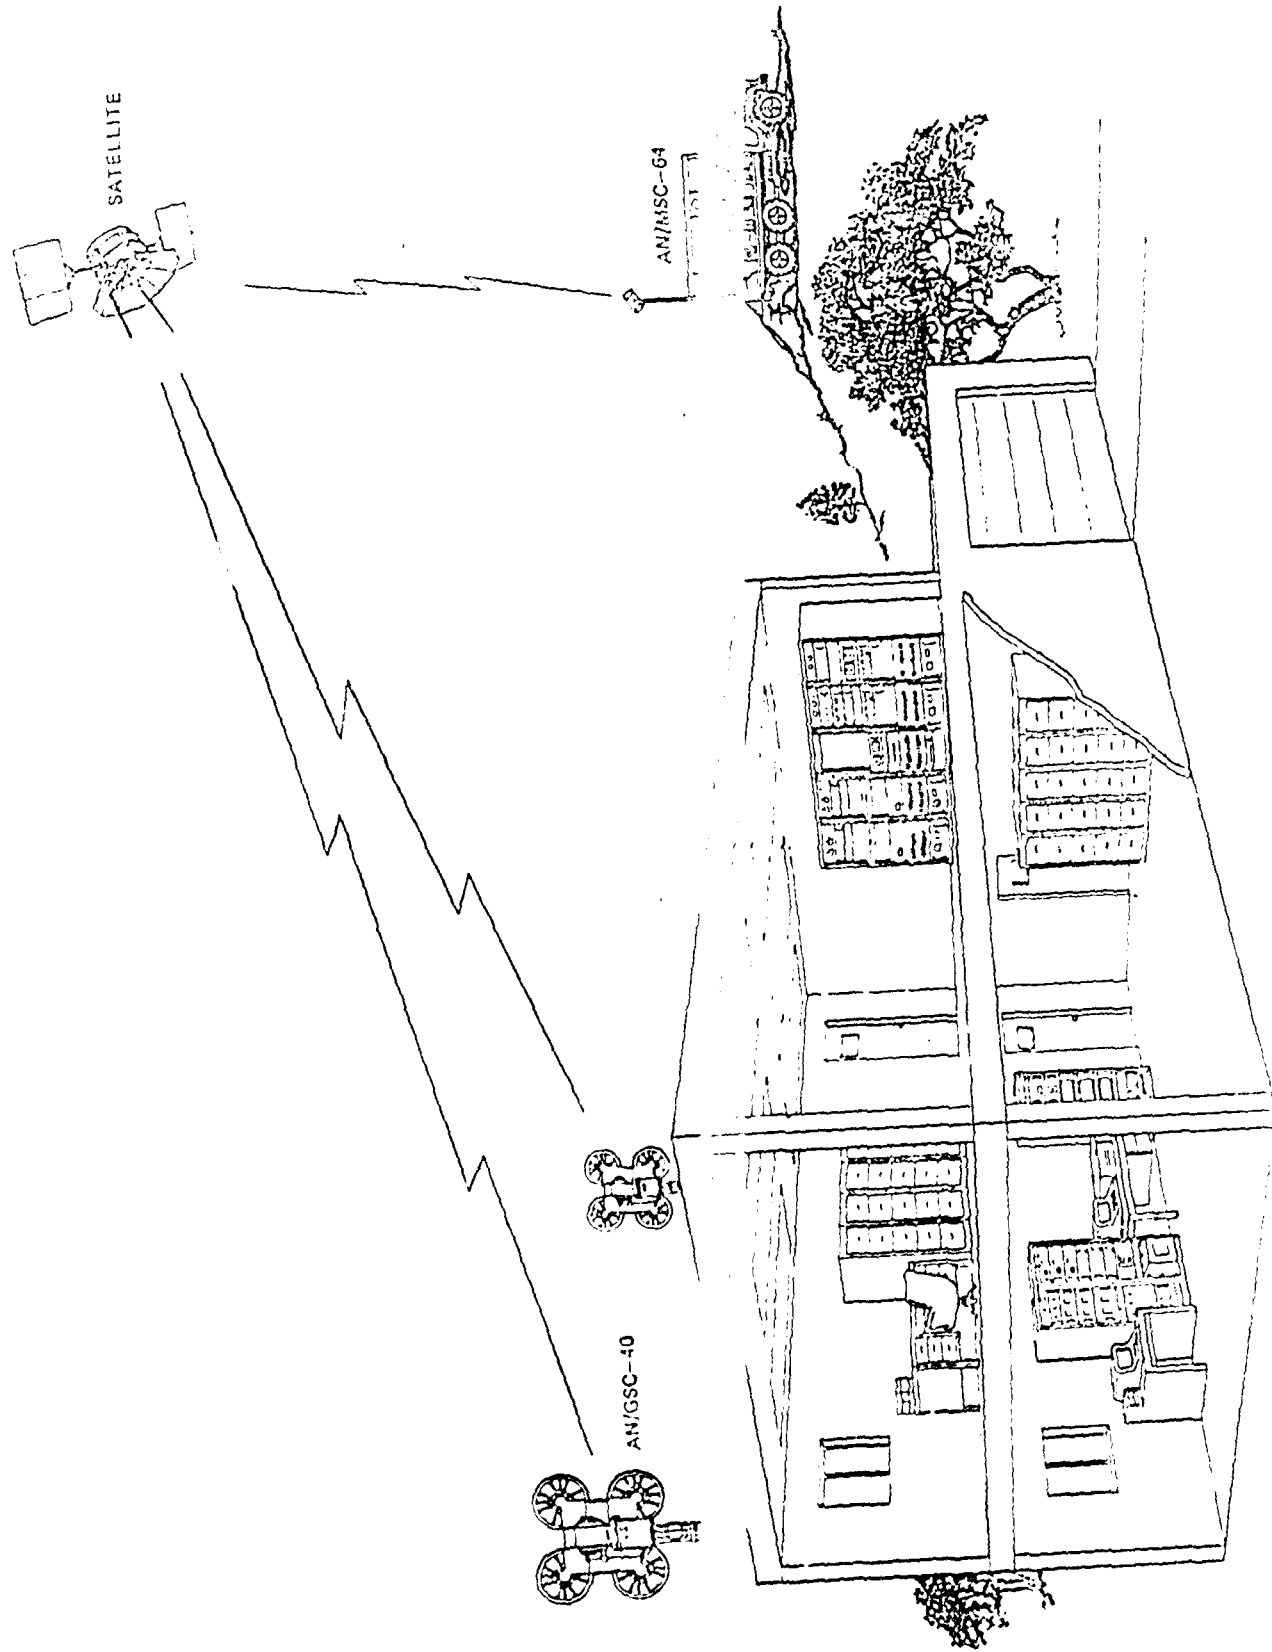
Figure 1. Typical AN/GSC-40 system configuration.

The AN/GSC-40 combined ground command post terminal is a satellite communications terminal employed for command and control in Europe and the Pacific. Two terminals were used for the test: one at United States European Command (USEUCOM) headquarters and one at United States Air Force in Europe (USAFE) headquarters. The AN/GSC-40 was designed to act as the command post for the Flaming Arrow Net (FAN) and to be interoperable with the AN/MS-64 force terminal, the airborne command post and those communications terminals now in use by the National Command Authority (NCA) and the Strategic Air Command (SAC). The AN/GSC-40 is shown in figure 1.

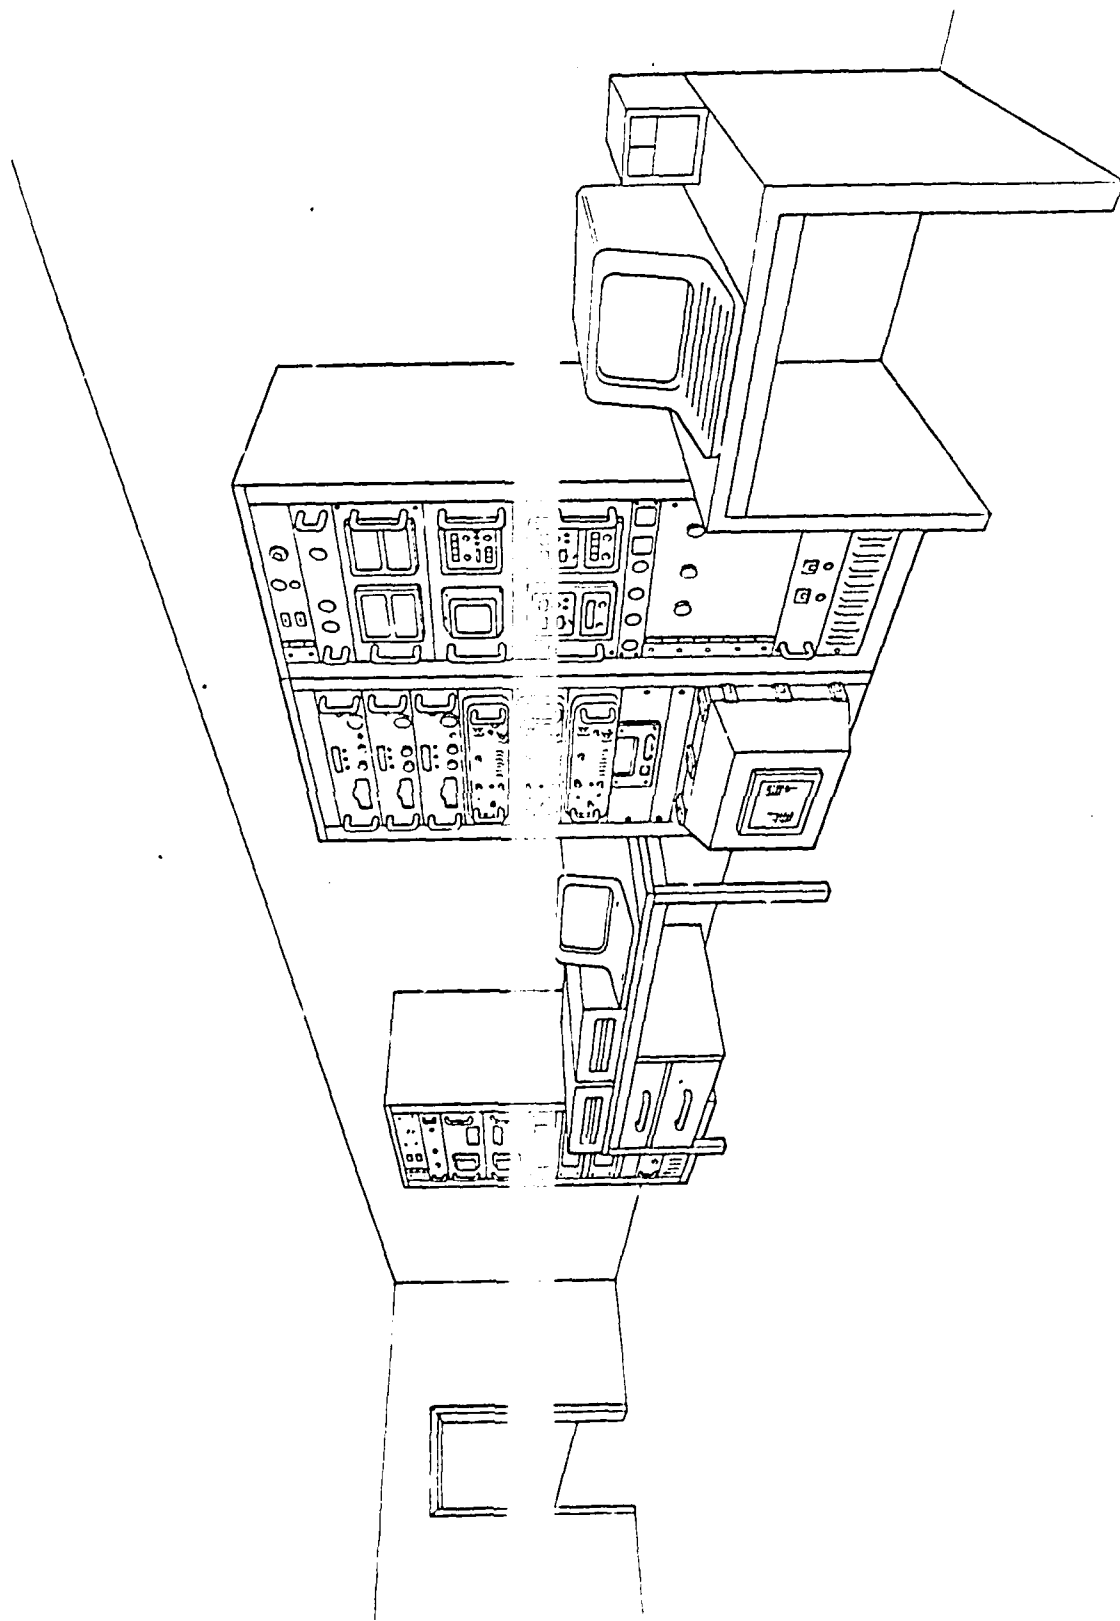
Figure 2. Typical AN/GSC-40 operation and command center.

The AN/GSC-40 equipment was physically located in two separate rooms at the command centers. Figure 2 depicts the system components found in the operations area. This system was manned by one operator 24 hours a day, seven days a week. Figure 3 depicts additional radio frequency (RF) equipment racks which were located in a separate room and connected to the equipment in the operations center by signal cables. The system maintainers watched over these latter five racks of equipment.

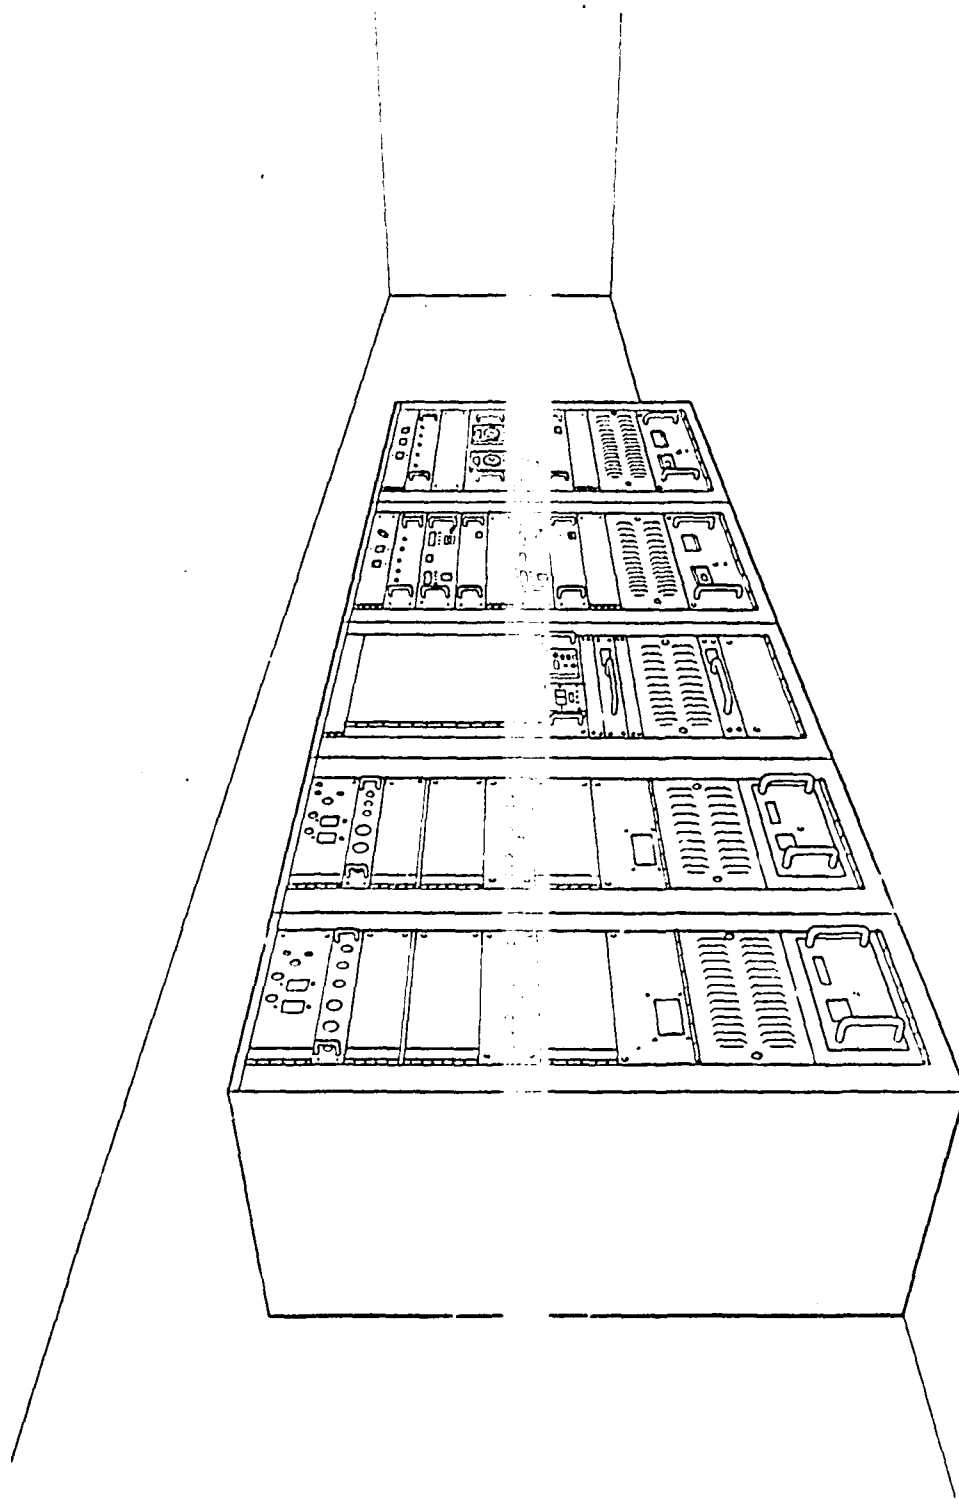
Figure 3. Typical AN/GSC-40 RF equipment room.
